REPORT NO. CASD/LVP 78-078  
CONTRACT NAS 3-20644

## ATLAS 5013 TANK CORROSION TEST

# ATLAS 5013 TANK CORROSION TEST

December 1978

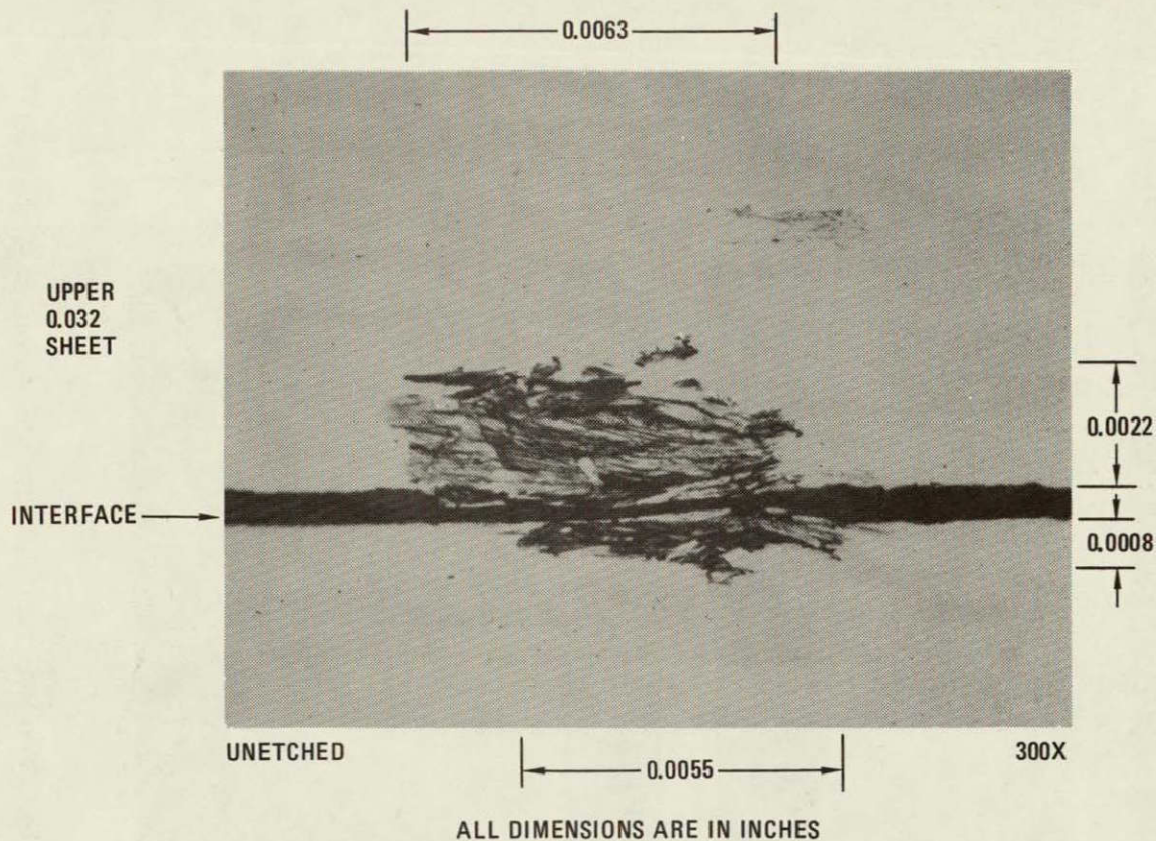
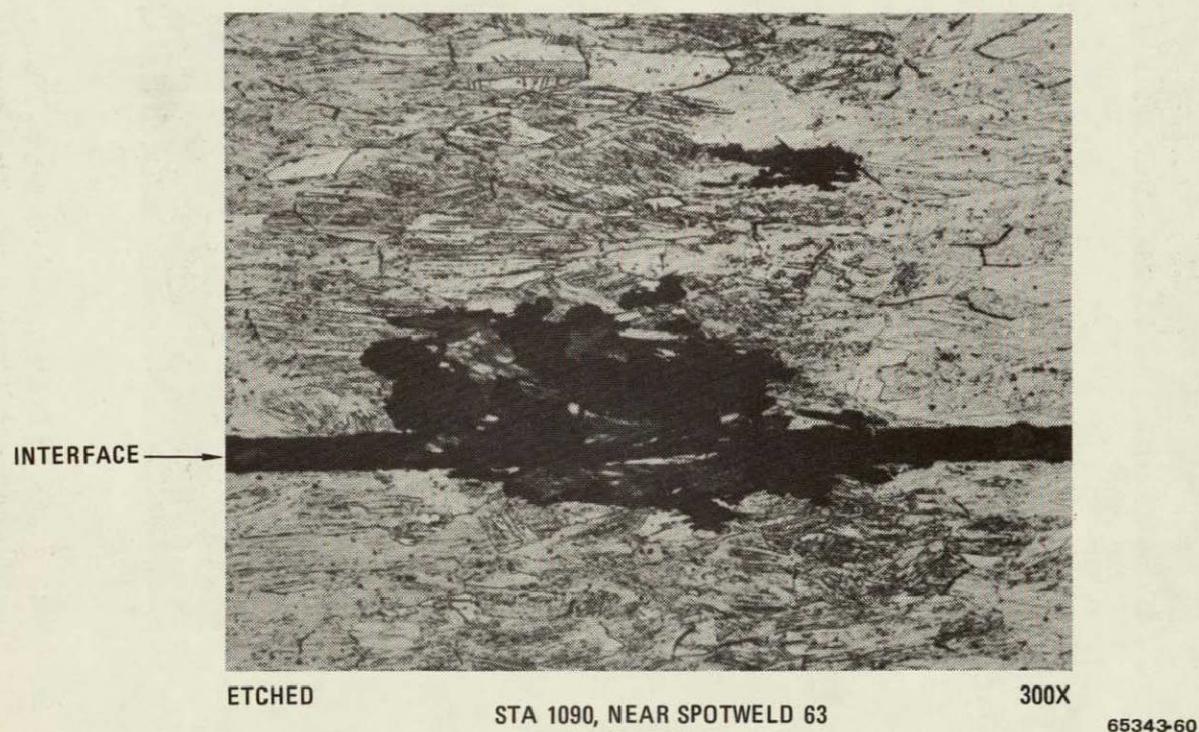
Figure 2-19. Portion of Figure 2-18 (B-B) at Higher Magnification (300X) Showing in Greater Detail the Appearance of the Corrosion Produced "Length" Defect in the Weld Carbide Zone. Dimensions of the Defect Prior to Etching are also Given

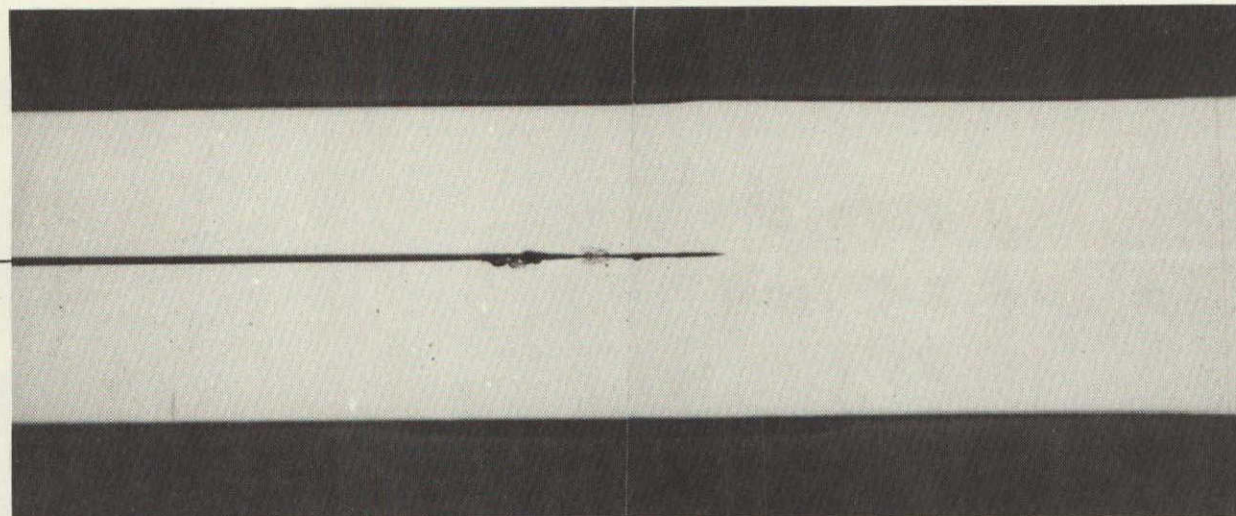
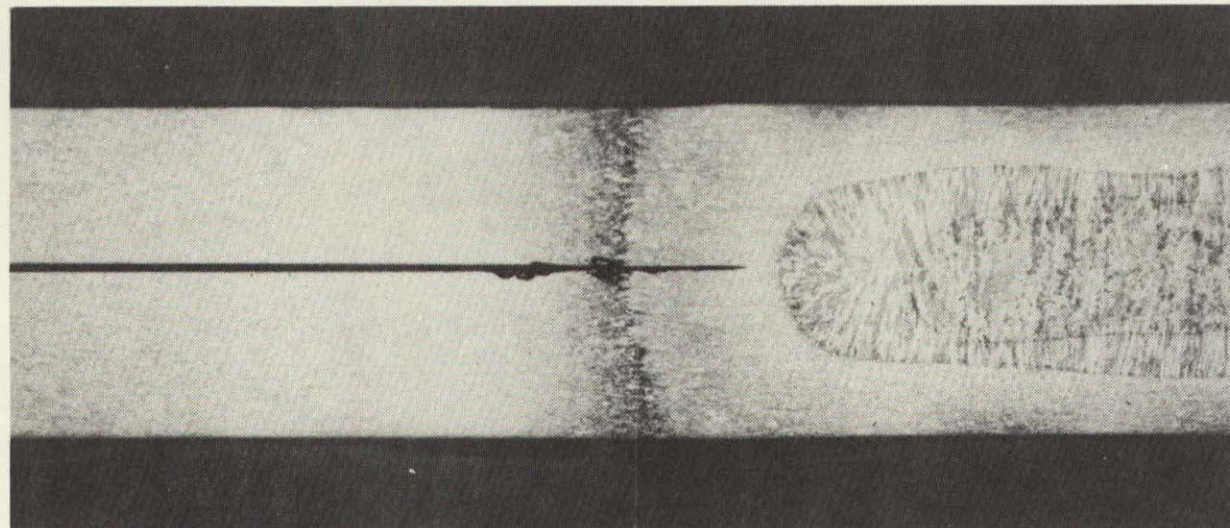
Figure 2-20. Appearance of Section C-C Shown in Figure 2-16. The Interface Defects are Shown at Higher Magnification in Figure 2-21. This Section is 0.040 Inch from Section B-B

2.4.3 "PITTING"-TYPE, LINEAR IMAGE. Item 5 (Figures 2-16 through 2-21) is a combination of a rounded and a linear "pitting"-type defect. The three section levels revealed that some of the pitting coincided with the weld-carbide precipitation zone (black band in the etched photomicrographs), not the internal, grain boundary carbides described earlier. The radiographic image associated with Section B-B is just barely visible. The total thickness of the defect at this location is 0.003 inch ( $0.0022 + 0.0008 = 0.0030$ ) or about 4.6% of the total sheet thickness (0.065 inch). This is considered to be, therefore, about the smallest (filled) "pitting"-type defect that can be detected by radiography. The distinctive blurred image, and its position outside the white crescents, can be used to identify this image as a "pitting"-type defect and not a stress corrosion crack. Item 6 is a combination of linear "pitting" and stress corrosion cracking.

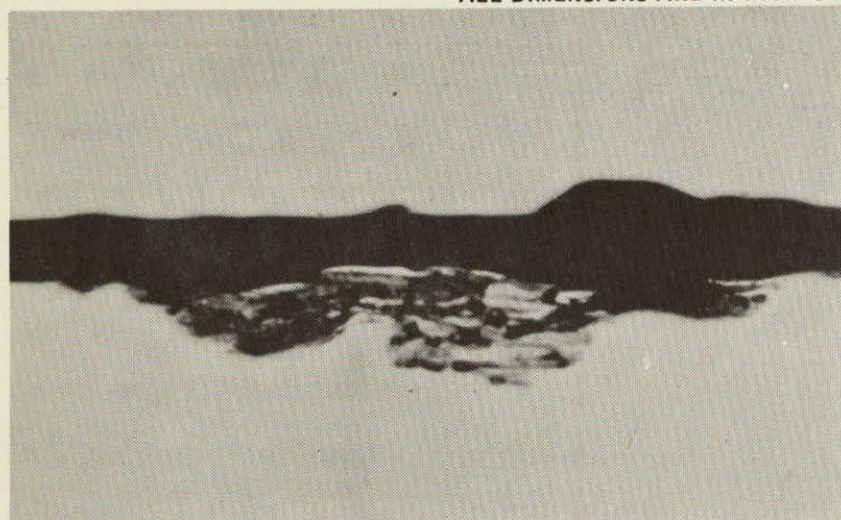
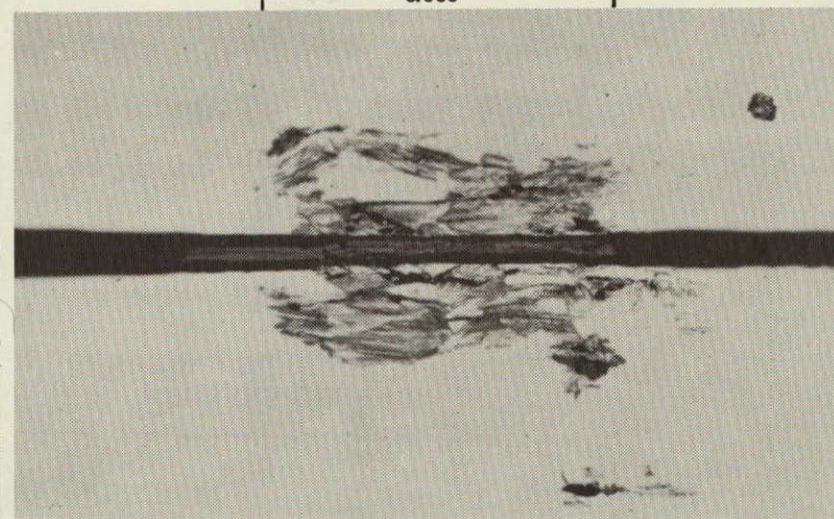
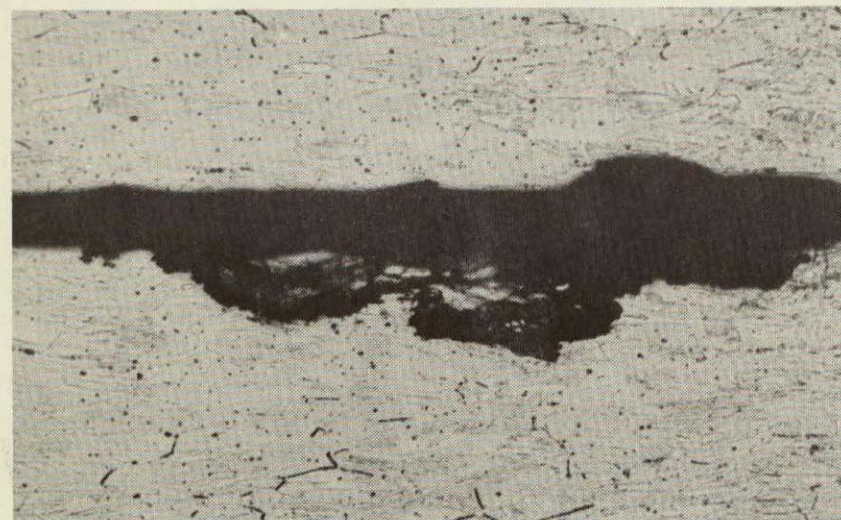
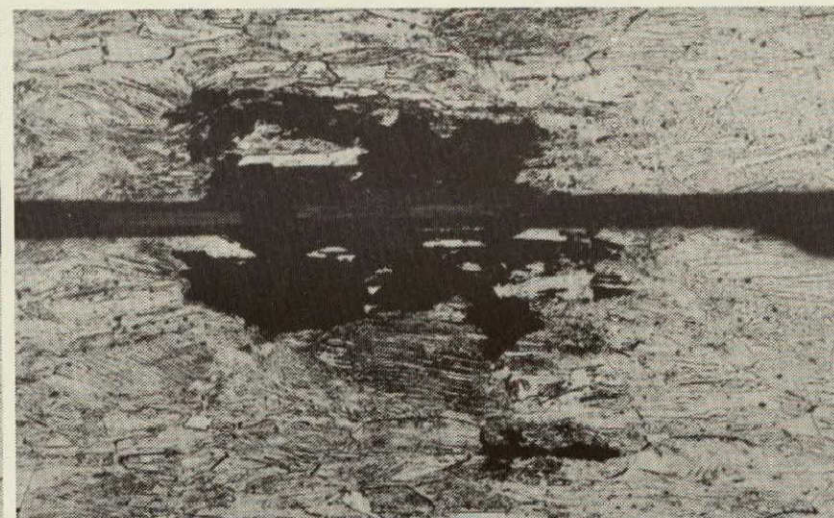
Figure 2-21. Portions of Figure 2-20 (C-C) at Higher Magnification (300X) Showing in Greater Detail the Appearance of the Corrosion Produced Defects at the Interface

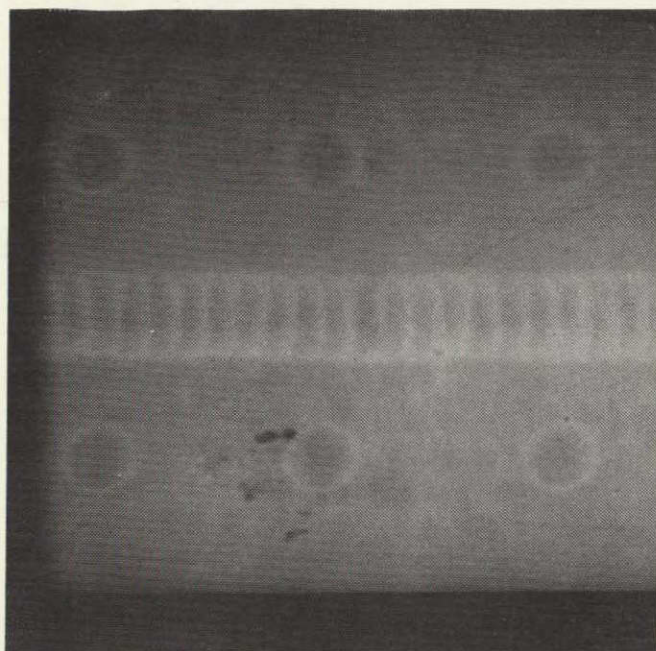
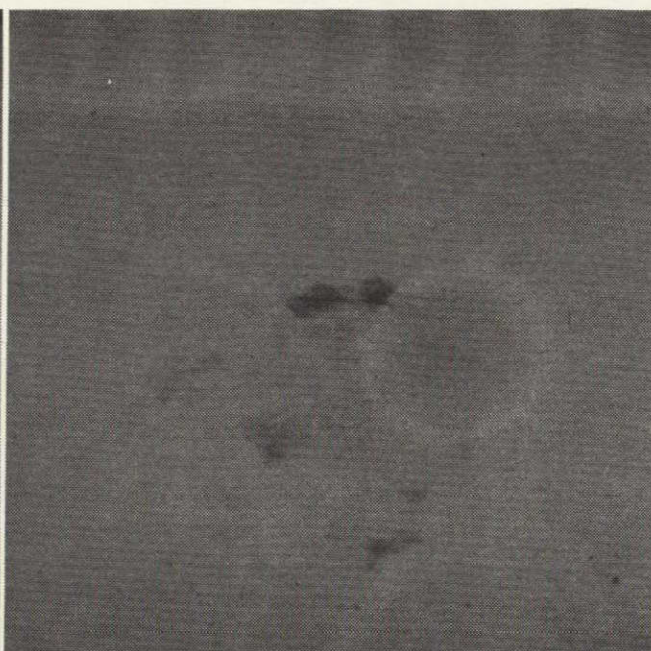
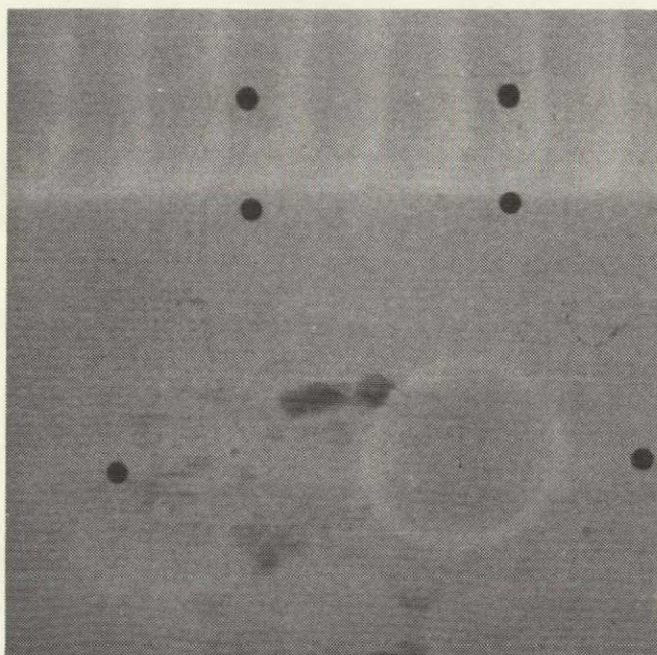
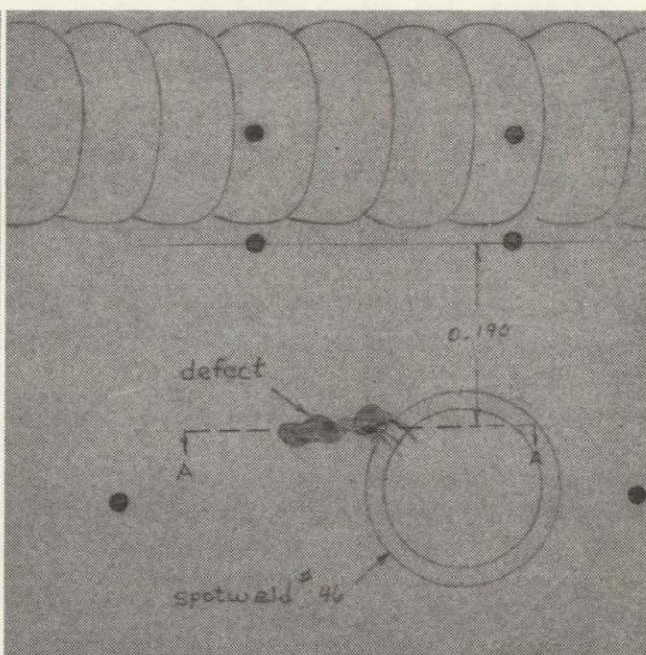
STA 1090 SPOTWELD 46

ABOVE — X-RAY IMAGE OF THE DEFECT MAGNIFIED 2 AND 5 TIMES  
X-RAY FILM 5X5001, 3-3A, 2-17-76, DENSITY 2.47

BELOW — SAME DEFECT WITH 6 MARKER HOLES ADDED  
X-RAY FILM M6, 5-12-76, DENSITY 3.22

Figure 2-22. Appearance of a Horizontal, "Length" Defect Indication Adjacent to a Spotweld (Item 6), and the Location of a Section (A-A) Through the Defect (see Figure 2-23)

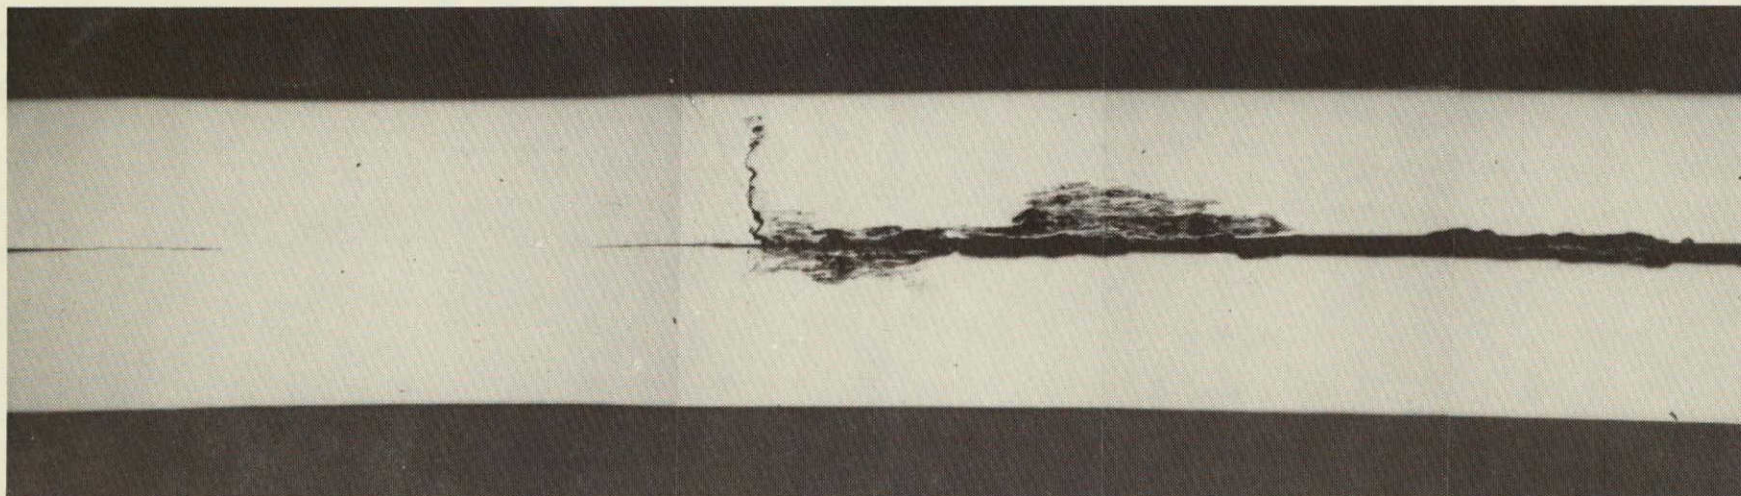
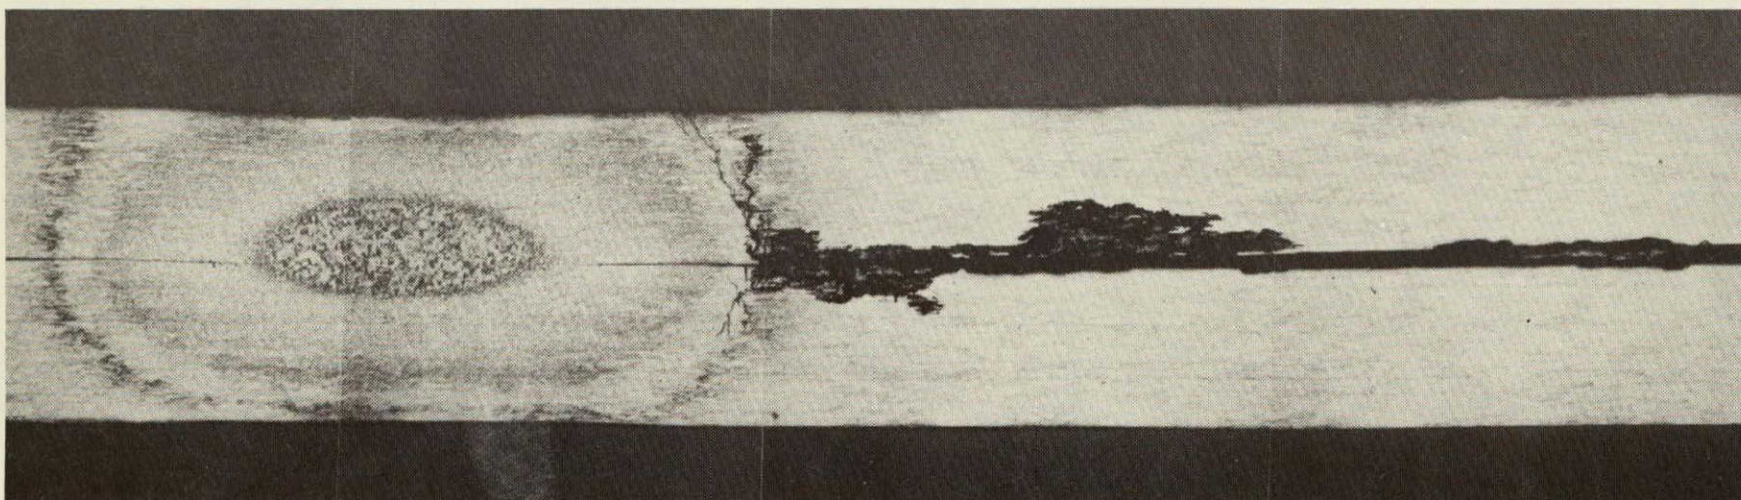
Figure 2-23. Appearance of Section (A-A) Through the Horizontal, "Length" Defect Indication Shown in Figure 2-22. Note the Stress Corrosion Cracks in the Heat-Affected Zone of the Spotweld

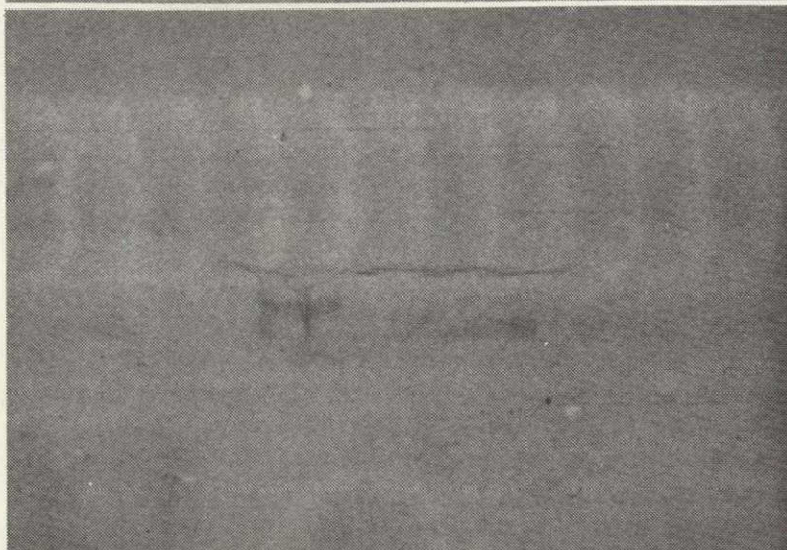
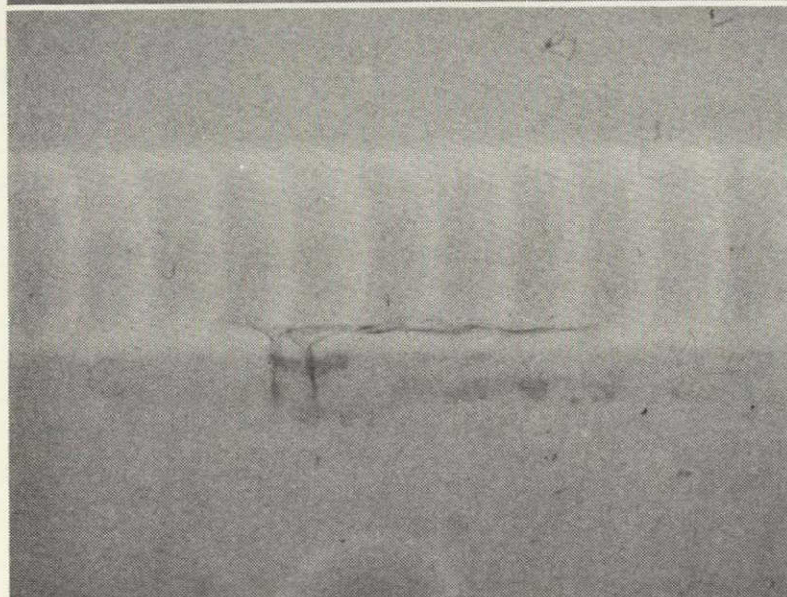
STA 1057, NEAR SPOTWELD 20

Figure 2-24. X-ray Appearance of a Leaky Vertical and a Leaky Horizontal Defect (Items 7 and 9) Associated with a Seamweld as Revealed by Three Different Films

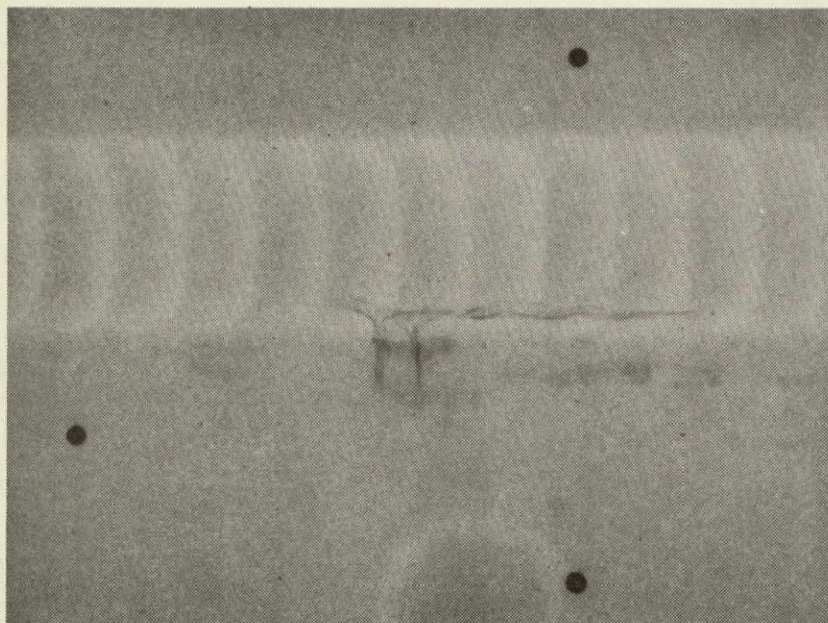
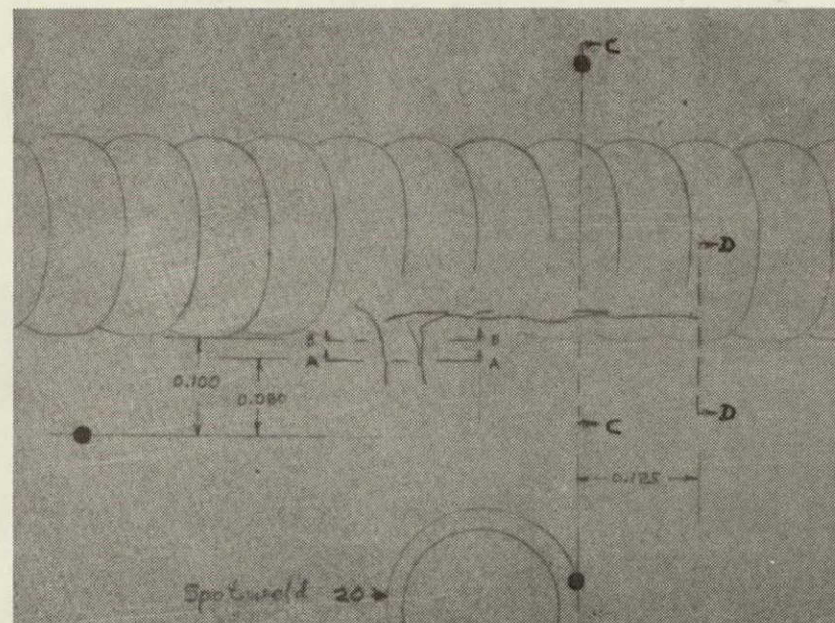
STA 1057, NEAR SPOTWELD 20

Figure 2-25. Same Defect Image as Shown in Figure 2-24 with 0.020-inch-diameter Marker Holes Added, X-ray Film M7, 8-16-76. The Sketch Shows the Locations of Two Sections (A-A and B-B) Through the Vertical Defects (Item 7) and Two Sections (C-C and D-D) Through the Horizontal Defect (Item 9)

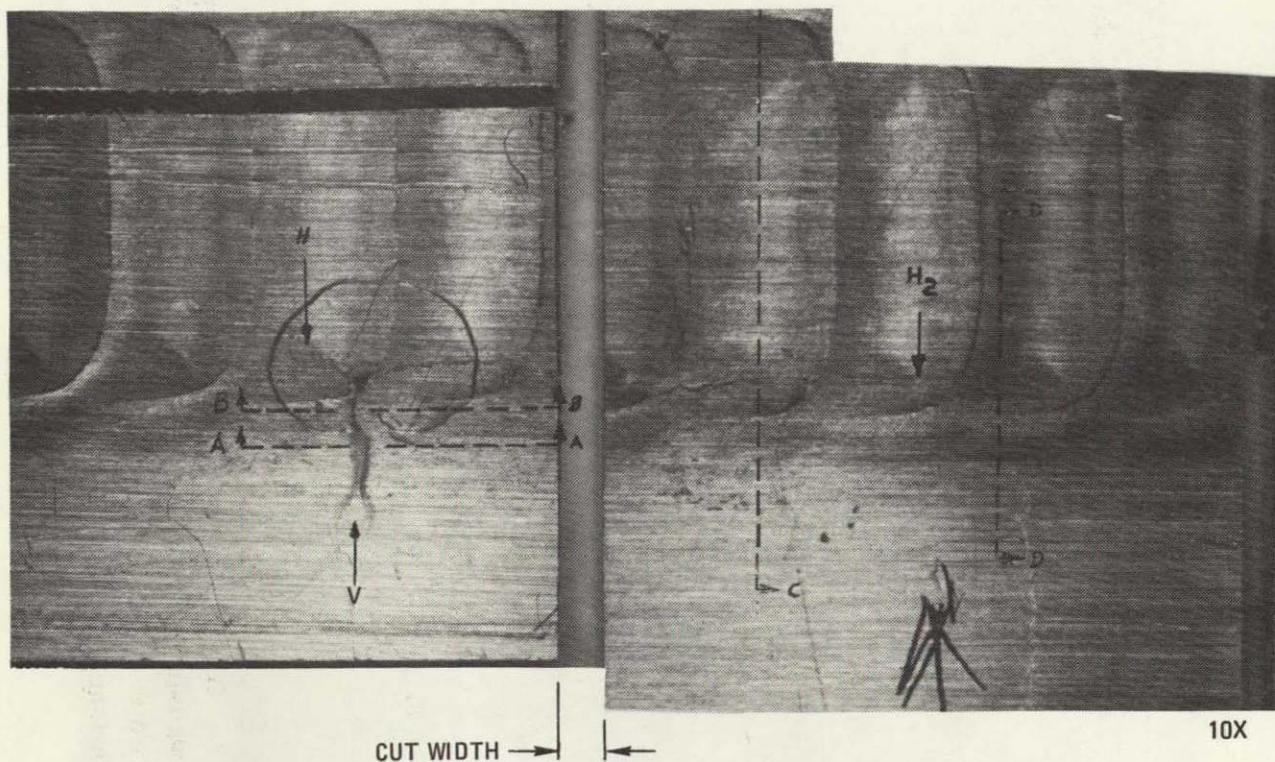
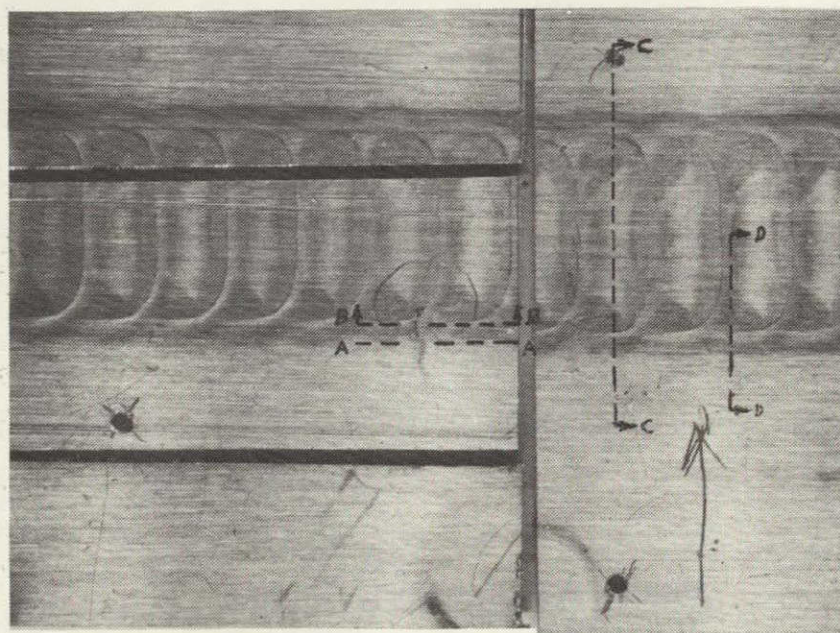
OPTICAL (LIGHT) PHOTOS  
STA 2057, NEAR SPOTWELD 20

Figure 2-26. Outside Surface Appearance of a Leaky Vertical Defect, Arrow V (Item 7) and a Leaky Horizontal Defect, from Arrow H to H<sub>2</sub> (Item 9) Associated with a Seamweld. Also Shown are Three 0.020-inch-diameter Marker Holes, and the Location of Four Metallographic Sections

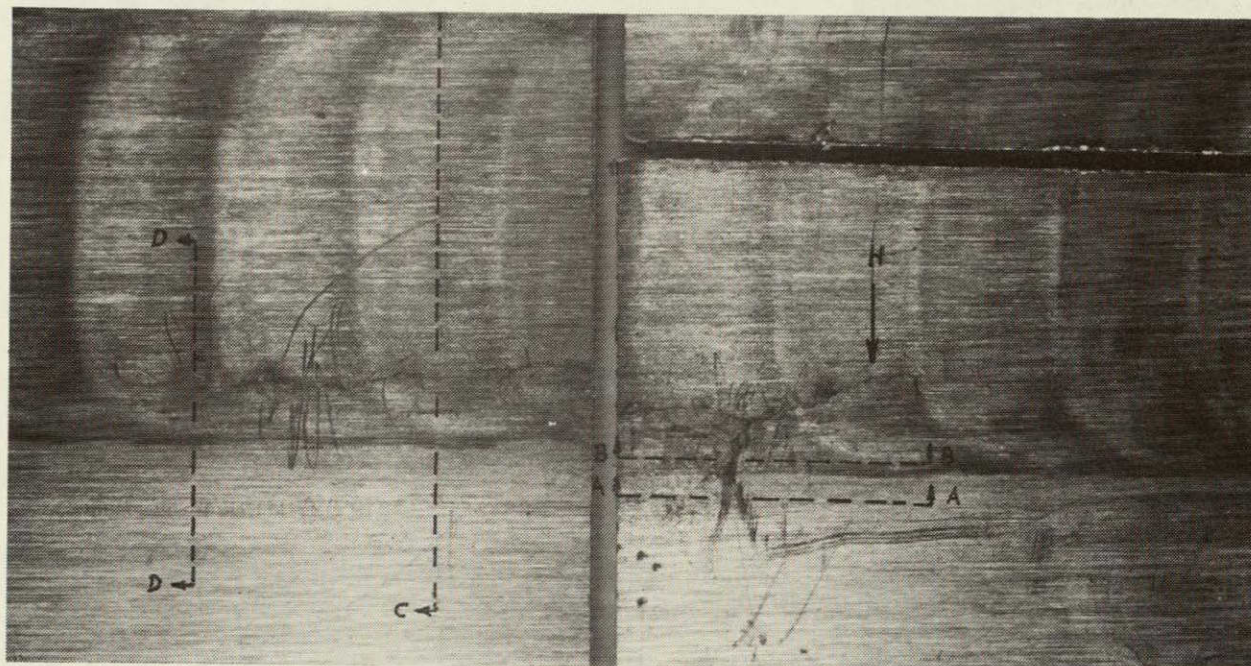
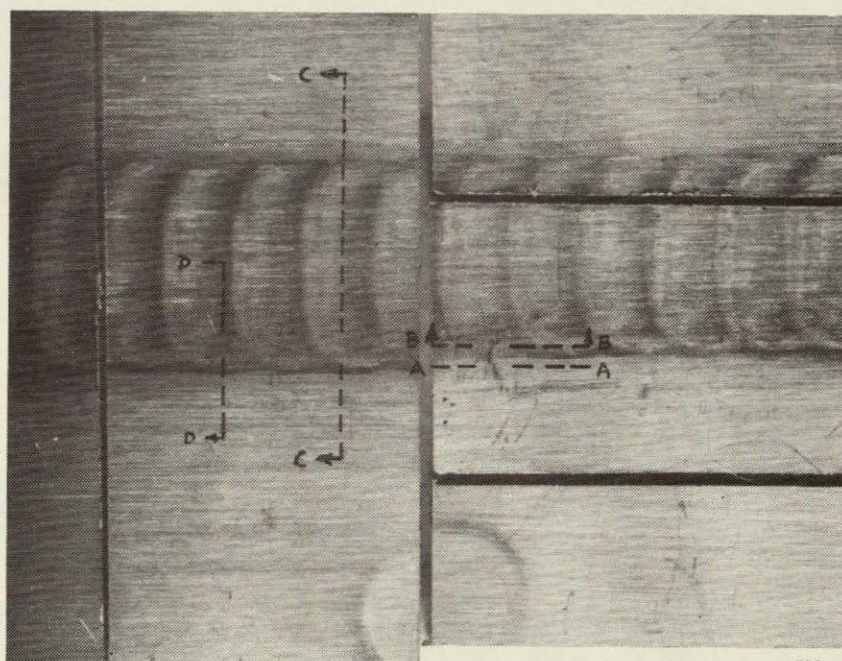
SPOT 20

Figure 2-27. Inside Surface Appearance of the Leaky Defect Shown in Figure 2-25, and the Location of the Four Sections. The Horizontal Surface Crack Extends from the D-D Section Line to Arrow H

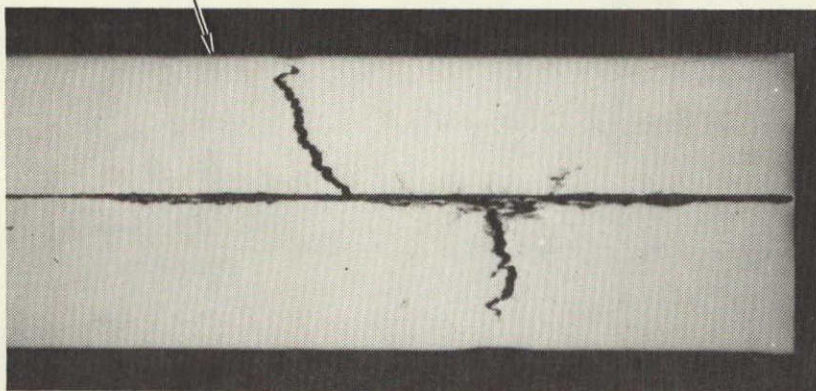
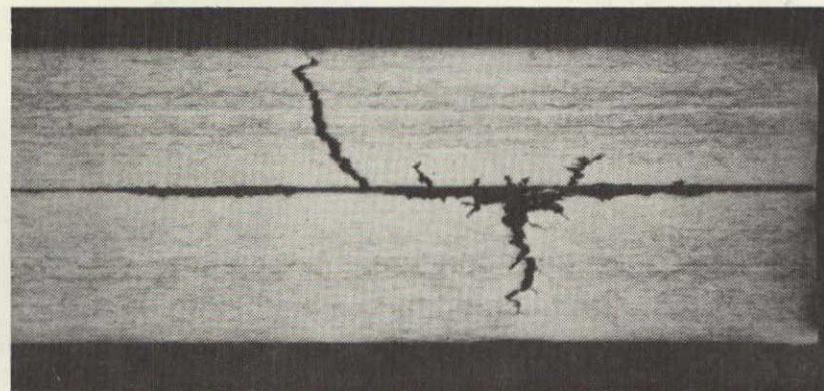
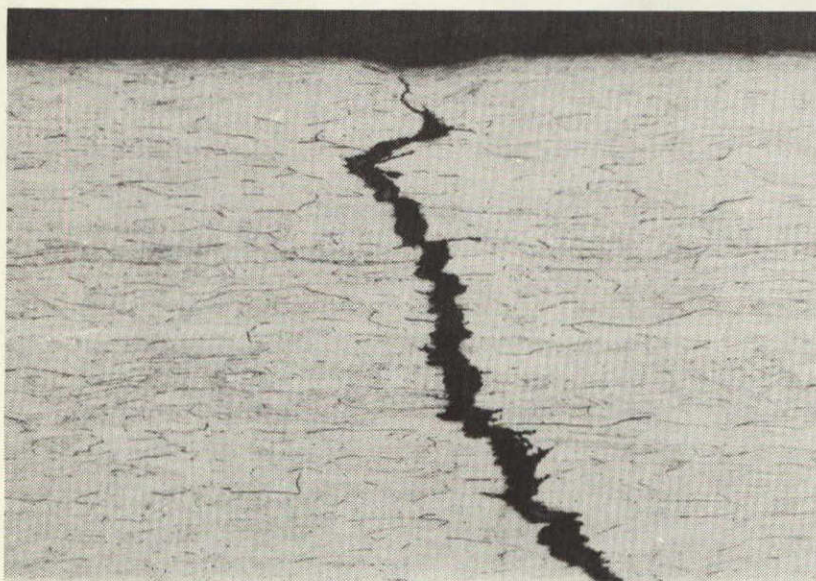
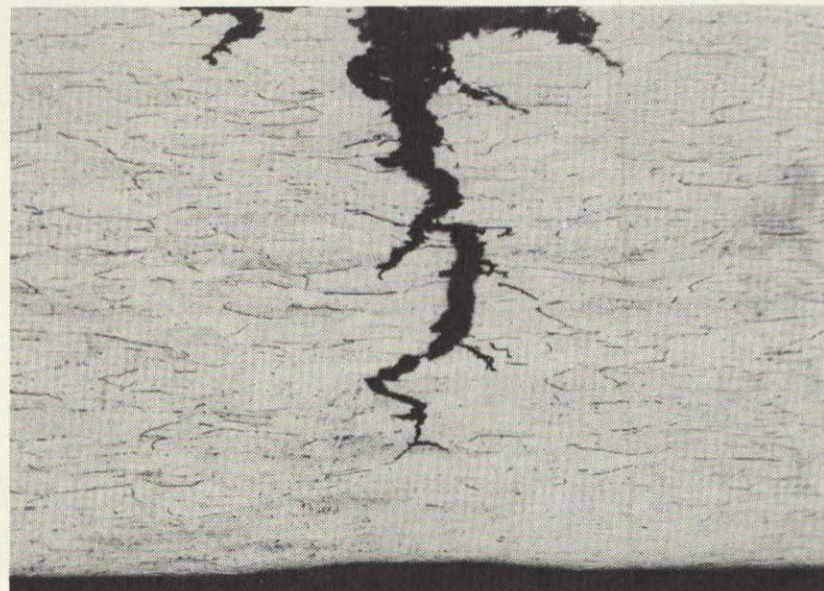
Figure 2-28. The Appearance of Section A-A Through the Vertical Defects Indications (see Figures 2-25, 2-26, and 2-27) is Shown Above. The Upper and Lower Crack Tips are Shown Below at Higher Magnification

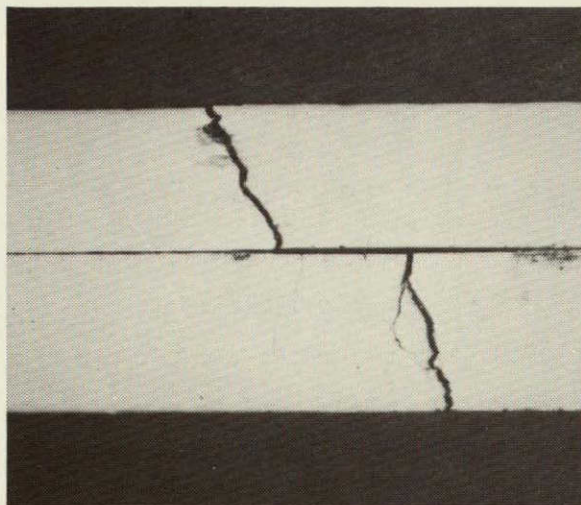
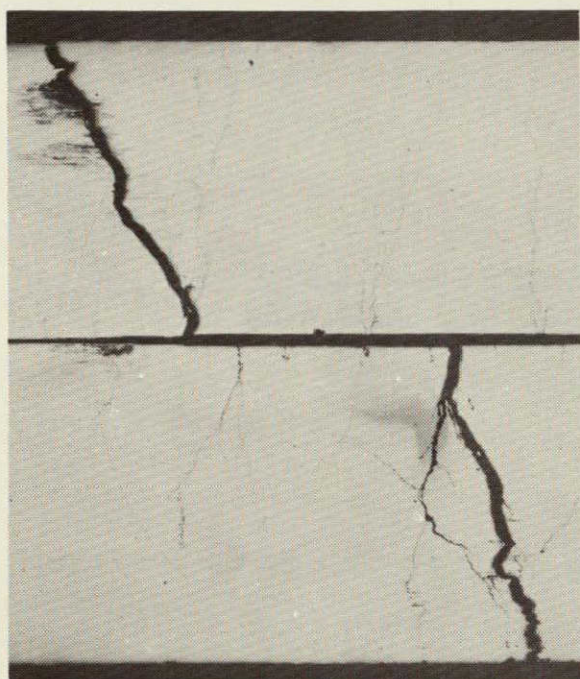
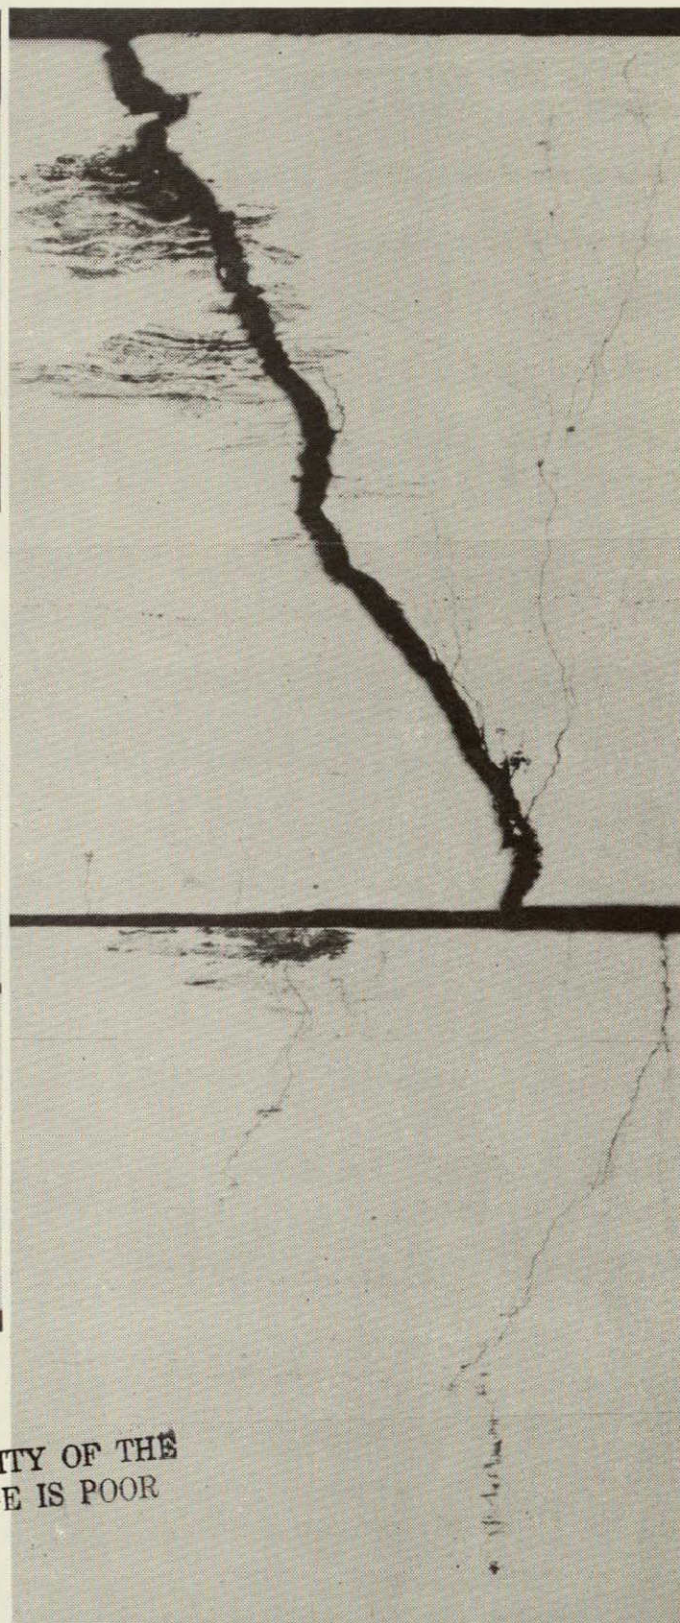
Figure 2-29. Section Level B-B (Figure 2-25). Portions of this Section, Above and to the Right, Reveal Many Fine Stress Corrosion Cracks Propagating from the Faying Surface Toward the Exterior Surfaces

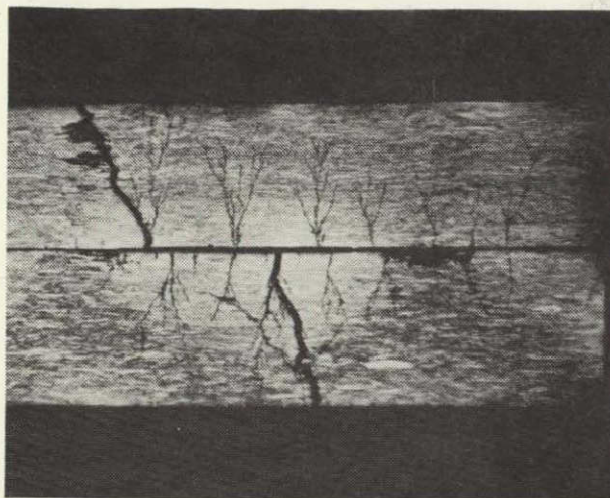
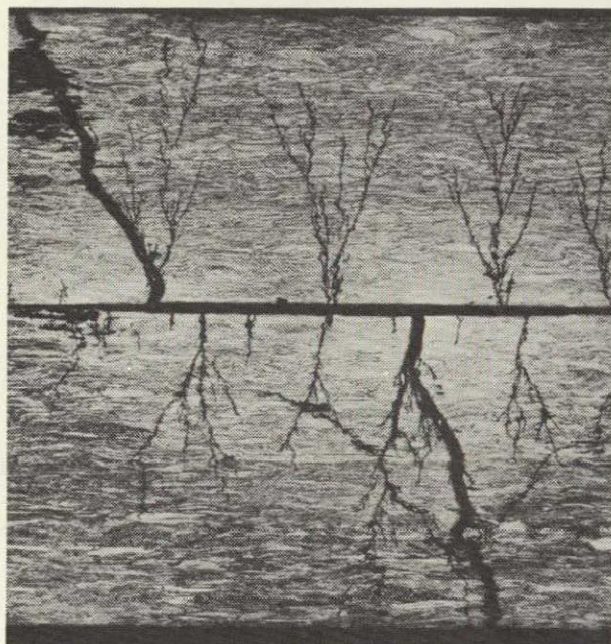
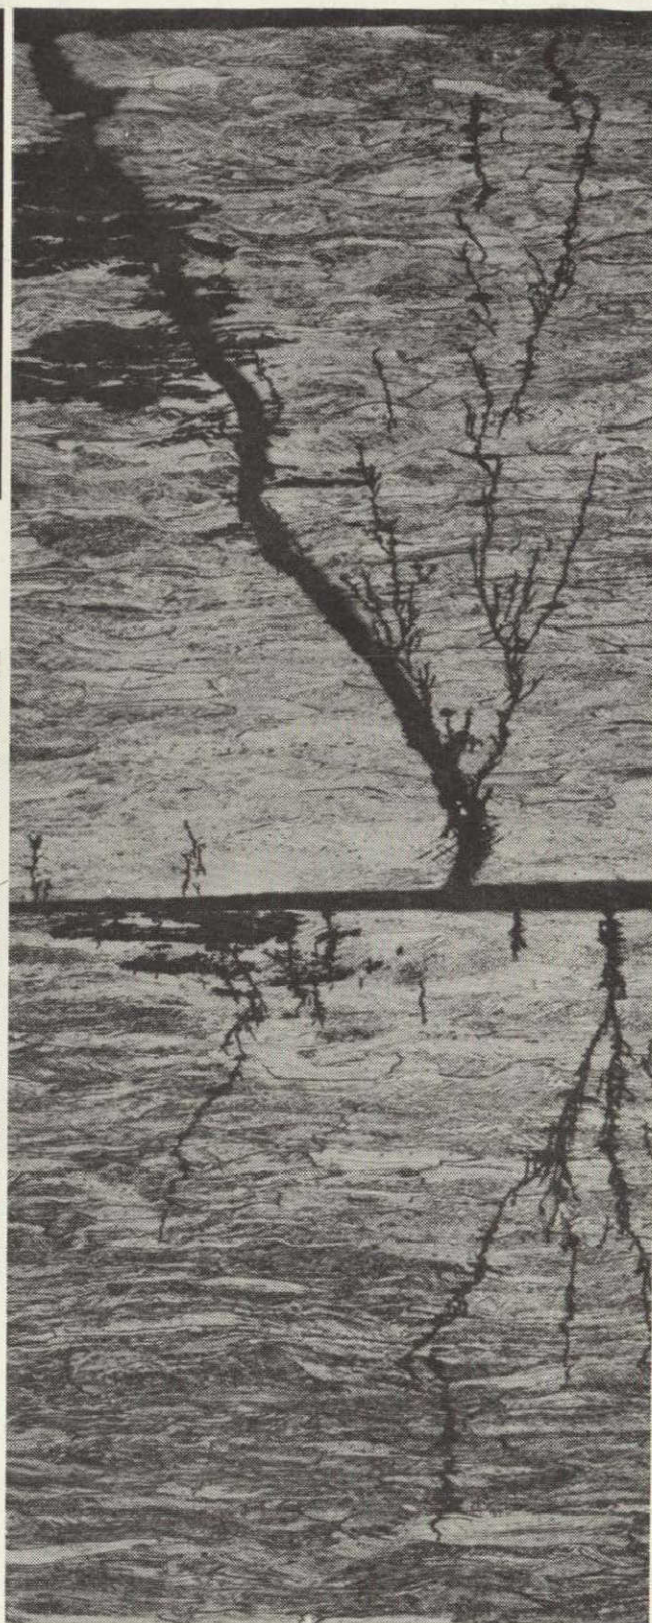
Figure 2-30. Same Areas Shown in Figure 2-29 after Etching. The Etching Broadens and Accentuates the Branching Stress Corrosion Cracks Emanating from the Faying Surface

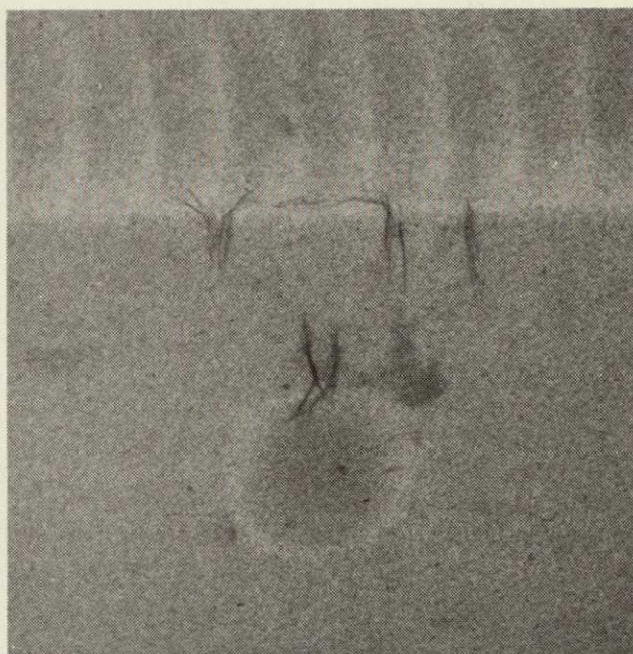
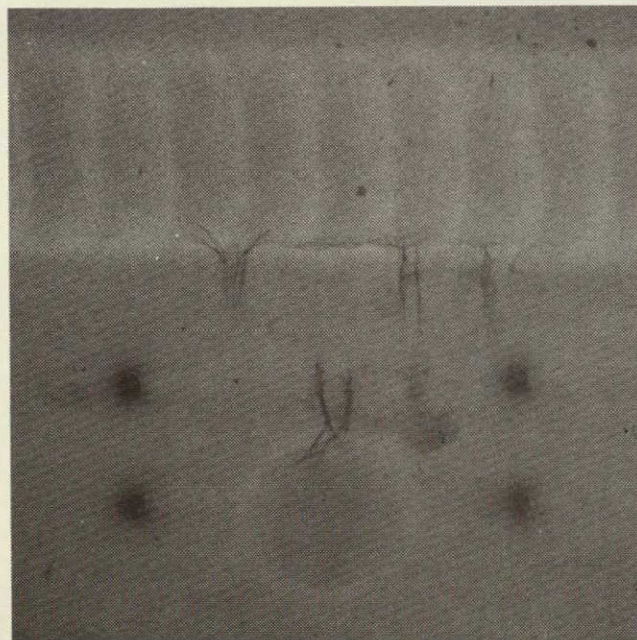
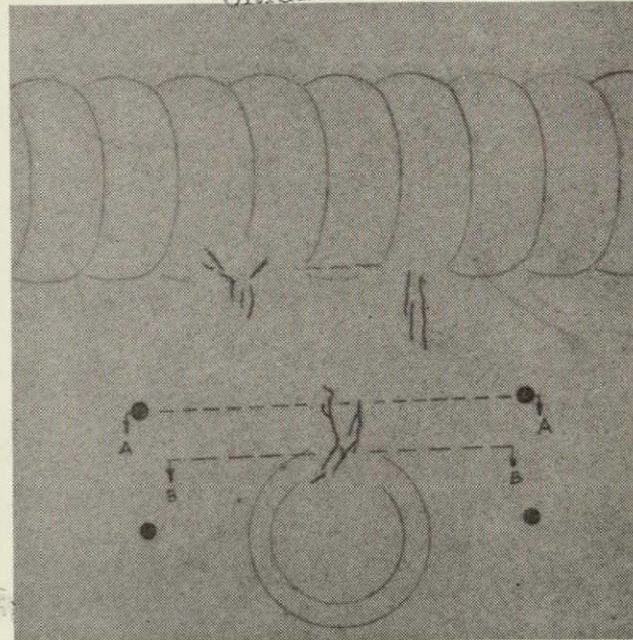
STA 1090 SPOTWELD 42

ABOVE - X-RAY IMAGE OF THE DEFECT MAGNIFIED 2 AND 5X  
X-RAY FILM 5X5001, 3-3A, 2-17-76, DENSITY 2.47

BELOW - SAME DEFECT WITH FOUR 0.021-IN. DIAMETER  
COMPLETELY THROUGH MARKER HOLES ADDED  
X-RAY FILM M8, 10-11-76, DENSITY 2.52

Figure 2-31. X-ray Appearance of a Leaky Vertical Defect Associated with a Spotweld (Item 8) and the Locations of Two Sections (A-A and B-B) Through the Defect (see Figures 2-34 and 2-35)

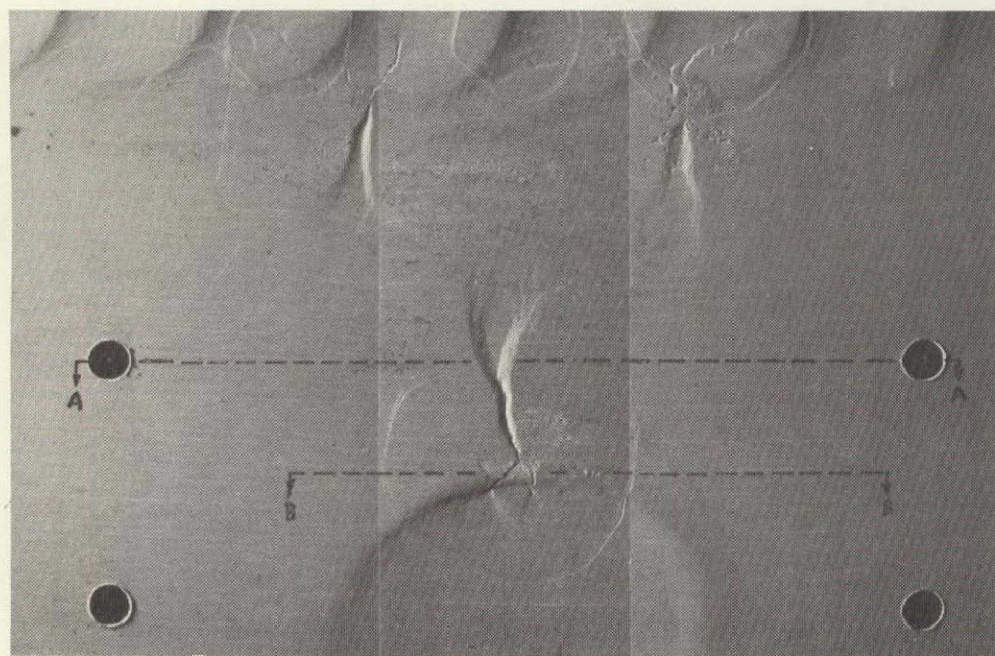
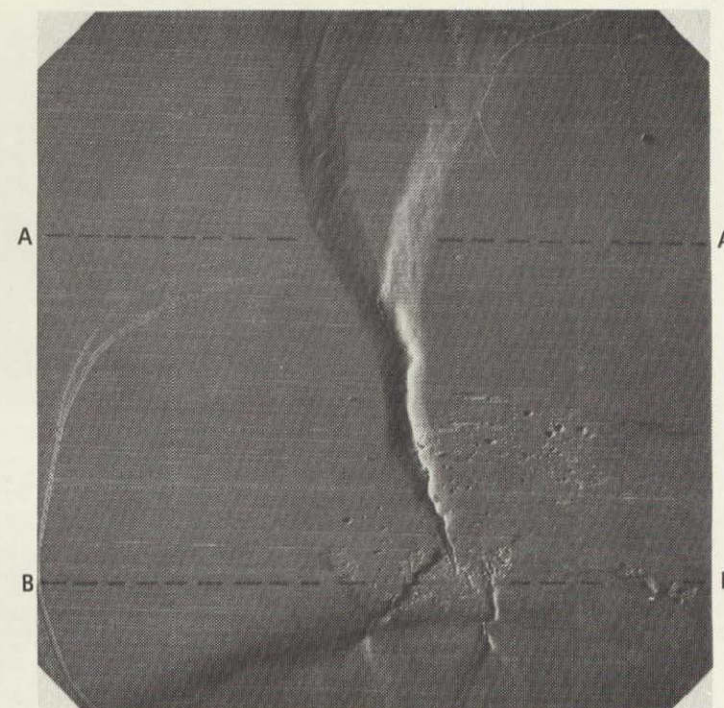
STA 1090, SPOTWELD 42

Figure 2-32. Outside Surface Appearance of a Leaky Vertical Defect Associated with a Spotweld (Item 8). Also Shown are Four 0.021-inch-diameter Marker Holes, and the Location of Two Metallographic Sections (see Figures 2-34 and 2-35). Note the V-shaped Depressions, Characteristic of Localized Yielding (Plastic Flow) at the Tip of a Crack (S.E.M. Photos)

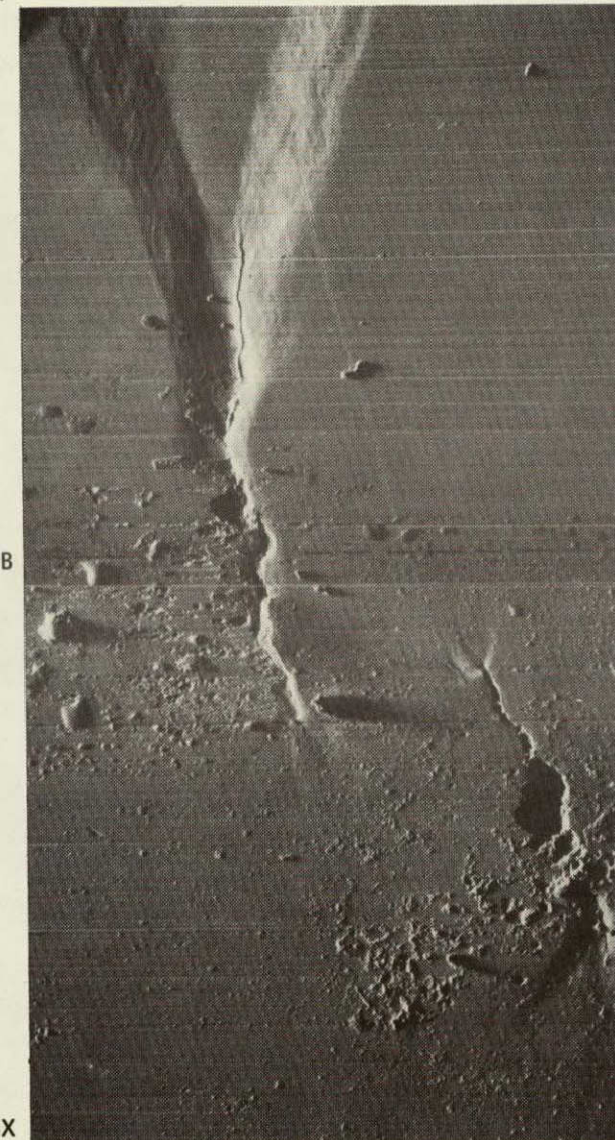
Figure 2-33. Inside Surface Appearance of a Leaky Vertical Defect Associated with the Same Spotweld Shown in Figure 2-31, and the Location of Two Metallographic Sections (see Figures 2-34 and 2-35)  
S.E.M. Photos
